Case History

Type of Project / Name:	Metal Roof Restoration / Cherokee Building Materials
Location:	Oklahoma City, OK
Specification:	RC-30-GF20
Contractor:	Coontz Roofing, Inc.
Customer:	Cherokee Building Materials of OKC, Inc.
Problem to be Solved:	Metal roof had developed many leaks.

Building material supplier solves leaking roof problems *with GacoFlex S20.*

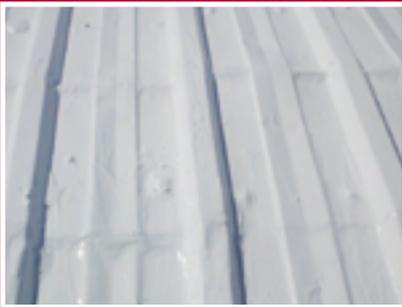
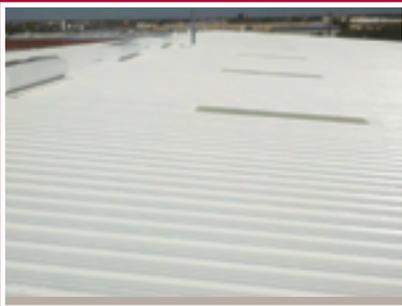
Once the roof area was cleaned with GacoWash Concentrated Cleaner and thoroughly power washed and allowed to dry completely, the entire roof received a coat of GacoFlex E5320 2-Part Epoxy Primer/Filler which was then allowed to dry. All fasteners, vertical and horizontal seams, skylight perimeters and other roof openings were sealed with GacoFlex SF2000 SeamSeal Solvent-Free Silicone Sealant to make these areas watertight. Much of the prep work to fasteners and seams had to be done by hand using brushes and rollers.

Once the entire roof was prepped, GacoFlex S20 Solvent-Free 100% Silicone Coating was applied over the entire roof area using a Gaco-modified Graco X70 Airless Sprayer with a 300 foot hose to reach across roof expanses.
